Limited Visual Dam Safety Inspections

OA00038

Reservoir 530

Limited Visual Dam Safety Inspection Conducted on: 4 April 2006

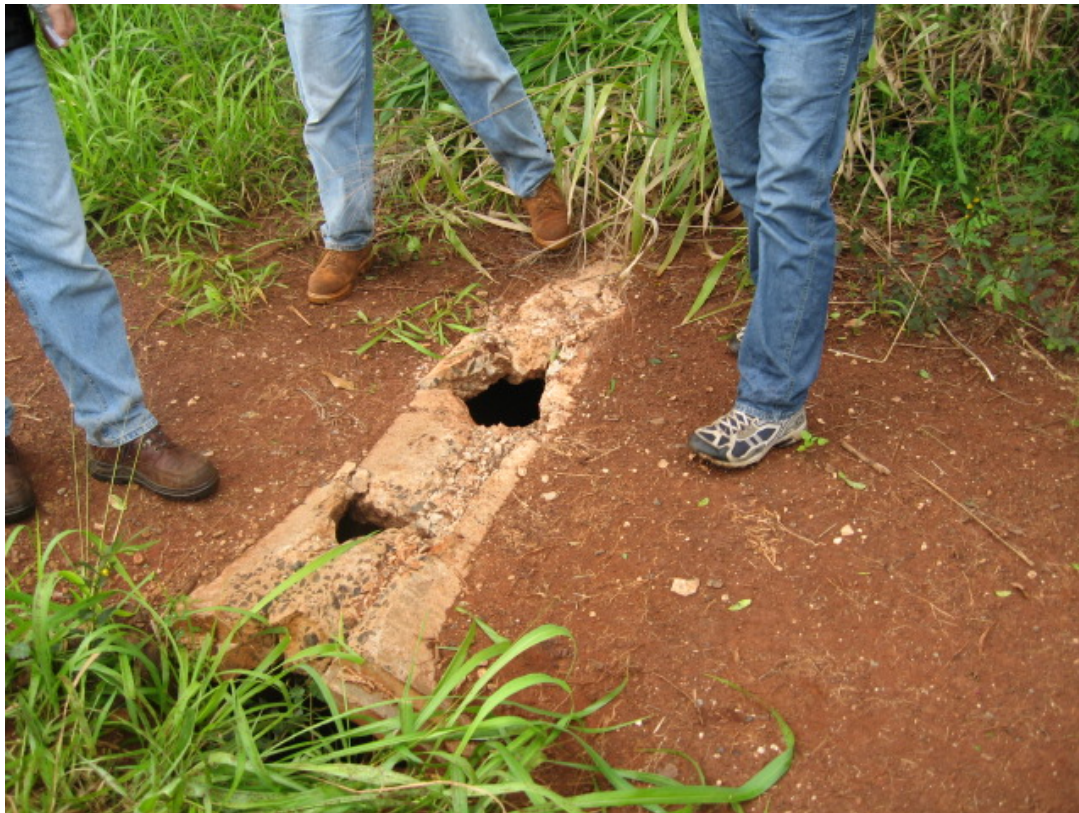
The spillway approach was highly vegetated; only one spillway could be found.

- a. The Spillway appeared to be in fair to poor condition and requires corrective action.
- b. The Spillway approach was blocked. Clear approach.
- c. Trees are unacceptable in the spillway channel and approach. Take corrective action to address the woody vegetation problem and repair the damaged area.
- d. Unclear if spillway is adequately sized. Spillway should pass the probable maximum flood. Verify spillway capacity and take corrective action as required.
- e. Clear second spillway at lower elevation.

Photo 1 Spillway on right side of dam.

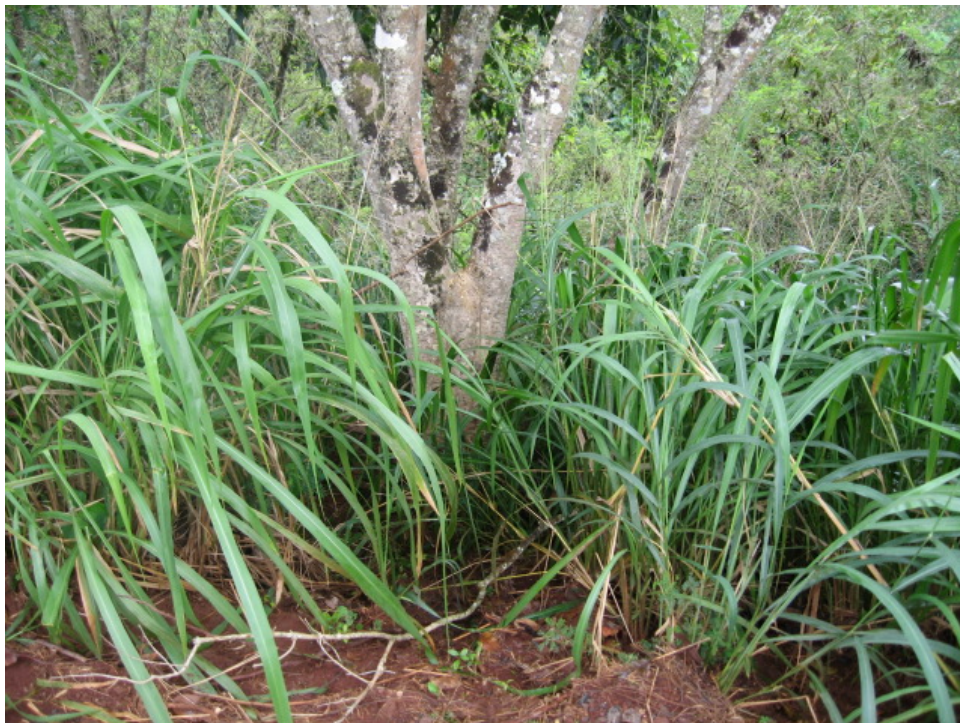
The downstream slope was in poor condition and not visible due to heavy vegetation.
The slope was very steep, around a 1 to 1 slope.
There was no access to the downstream slope / a roadway along the downstream toe.
There was some rip rap slope protection observed on the downstream slope.
Erosion was not observed on the downstream slope, however the slope was not entirely visible.
Sinkholes were not observed on the downstream slope, however the slope was not entirely visible.
Vegetation was observed on the downstream slope. The majority of the vegetation was woody trees of various size.
Seepage was not observed on the downstream toe, however the slope was not entirely visible.

- a. The downstream slope was not inspected.
- b. The downstream slope appeared to be in fair to poor condition and requires corrective action.
- c. The down stream slope was not visible due to high grass and bush vegetation. Clear high vegetation and maintain low to enable easy visual inspection.

- d. Tree(s) were observed on the downstream slope. Trees have been identified as the probably cause of piping failures, and can possibly cause severe damage to the embankment if they are uprooted during a high winds. Corrective action is required to remove the tree hazards from the dam. Acceptable remedies include removal of the tree and its root structure down to a 2" diameter and reconstructing the damaged embankment section. All repair work shall be accomplished as per the requirements of licensed geotechnical or structural engineer. Routinely monitor the damaged area for signs of settlement and seepage.

Photo 2 Downstream slope, dense vegetation.

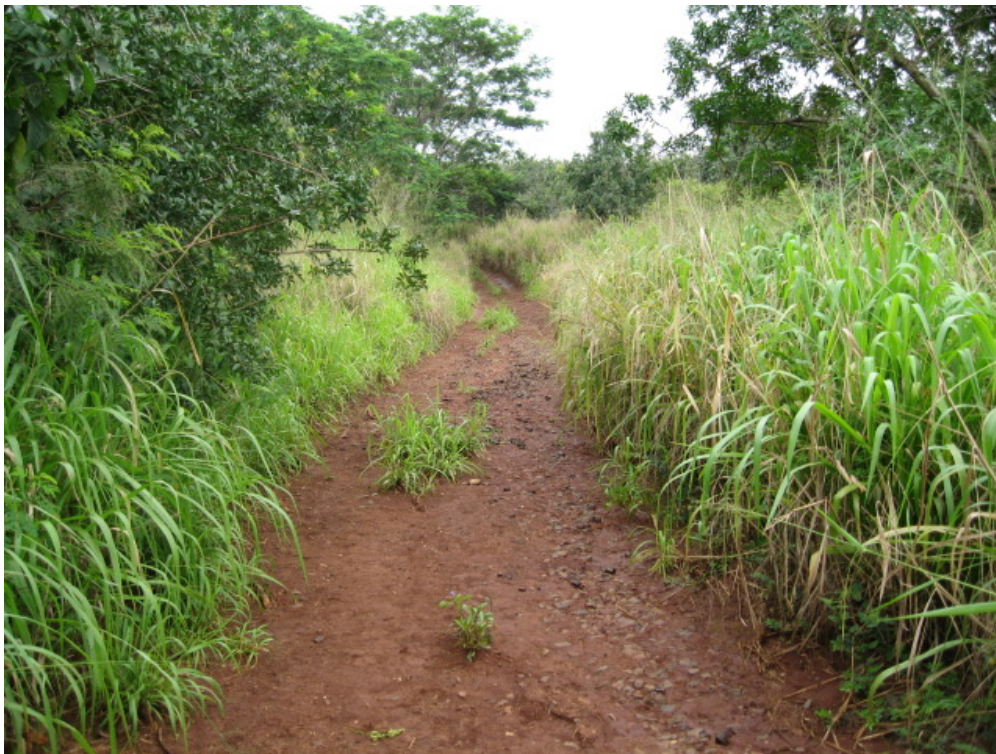
The dam crest was approximately 19 feet wide
There was a dirt access road on top of the crest.
There was high vegetation on either edges of the crest.
Cracks were not observed, however the crest was not entirely visible.
Sinkholes were not observed, however the crest was not entirely visible.
Vegetation was observed on the edges of the crest, including numerous trees of varying size and small woody vegetation and high grass.

- a. The dam crest was not inspected.
- b. The dam crest appeared to be in fair to poor condition and requires corrective action.
- c. Access along the crest was satisfactory.

- e. Tree(s) were observed along the dam crest. Trees have been identified as the probable cause of piping failures, and can possibly cause severe damage to the embankment if they are uprooted during a high winds. Corrective action is required to remove the tree hazards from the dam. Acceptable remedies include removal of the tree and its root structure down to a 2" diameter and reconstructing the damaged embankment section. All repair work shall be accomplished as per the requirements of licensed geotechnical or structural engineer. Routinely monitor the damaged area for signs of settlement and seepage.

Photo 3 Dam crest.

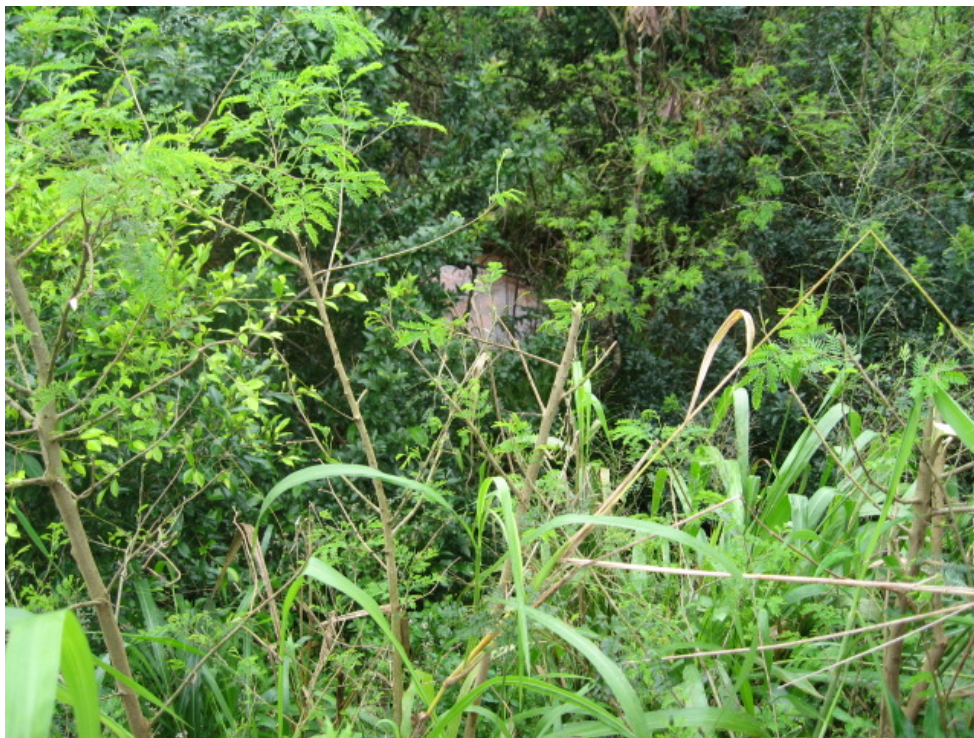
A fitted rip rap rock slope protection was observed. Vegetation was observed growing between the rocks.

- a. The upstream slope was not inspected.
- b. The upstream slope appeared to be in fair to poor condition and requires corrective action.
- c. The upstream slope was not visible due to high grass and bush vegetation. Clear high vegetation and maintain low to enable easy visual inspection.
- d. Tree(s) were observed on the dam embankment. Trees have been identified as the probably cause of piping failures, and can possibly cause severe damage to the embankment if they are uprooted during a high winds. Corrective action is

required to remove the tree hazards from the dam. Acceptable remedies include removal of the tree and its root structure down to a 2" diameter and reconstructing the damaged embankment section. All repair work shall be accomplished as per the requirements of licensed geotechnical or structural engineer. Routinely monitor the damaged area for signs of settlement and seepage.

Photo 4 Upstream slope, dense vegetation.
